TECHNICAL INSPECTION REPORT.

⑥ OPERATION CROSSROADS.
U.S.S SKIPJACK (SS184)

TEST ABLE [U].

USS SKIPJACK (SS184)

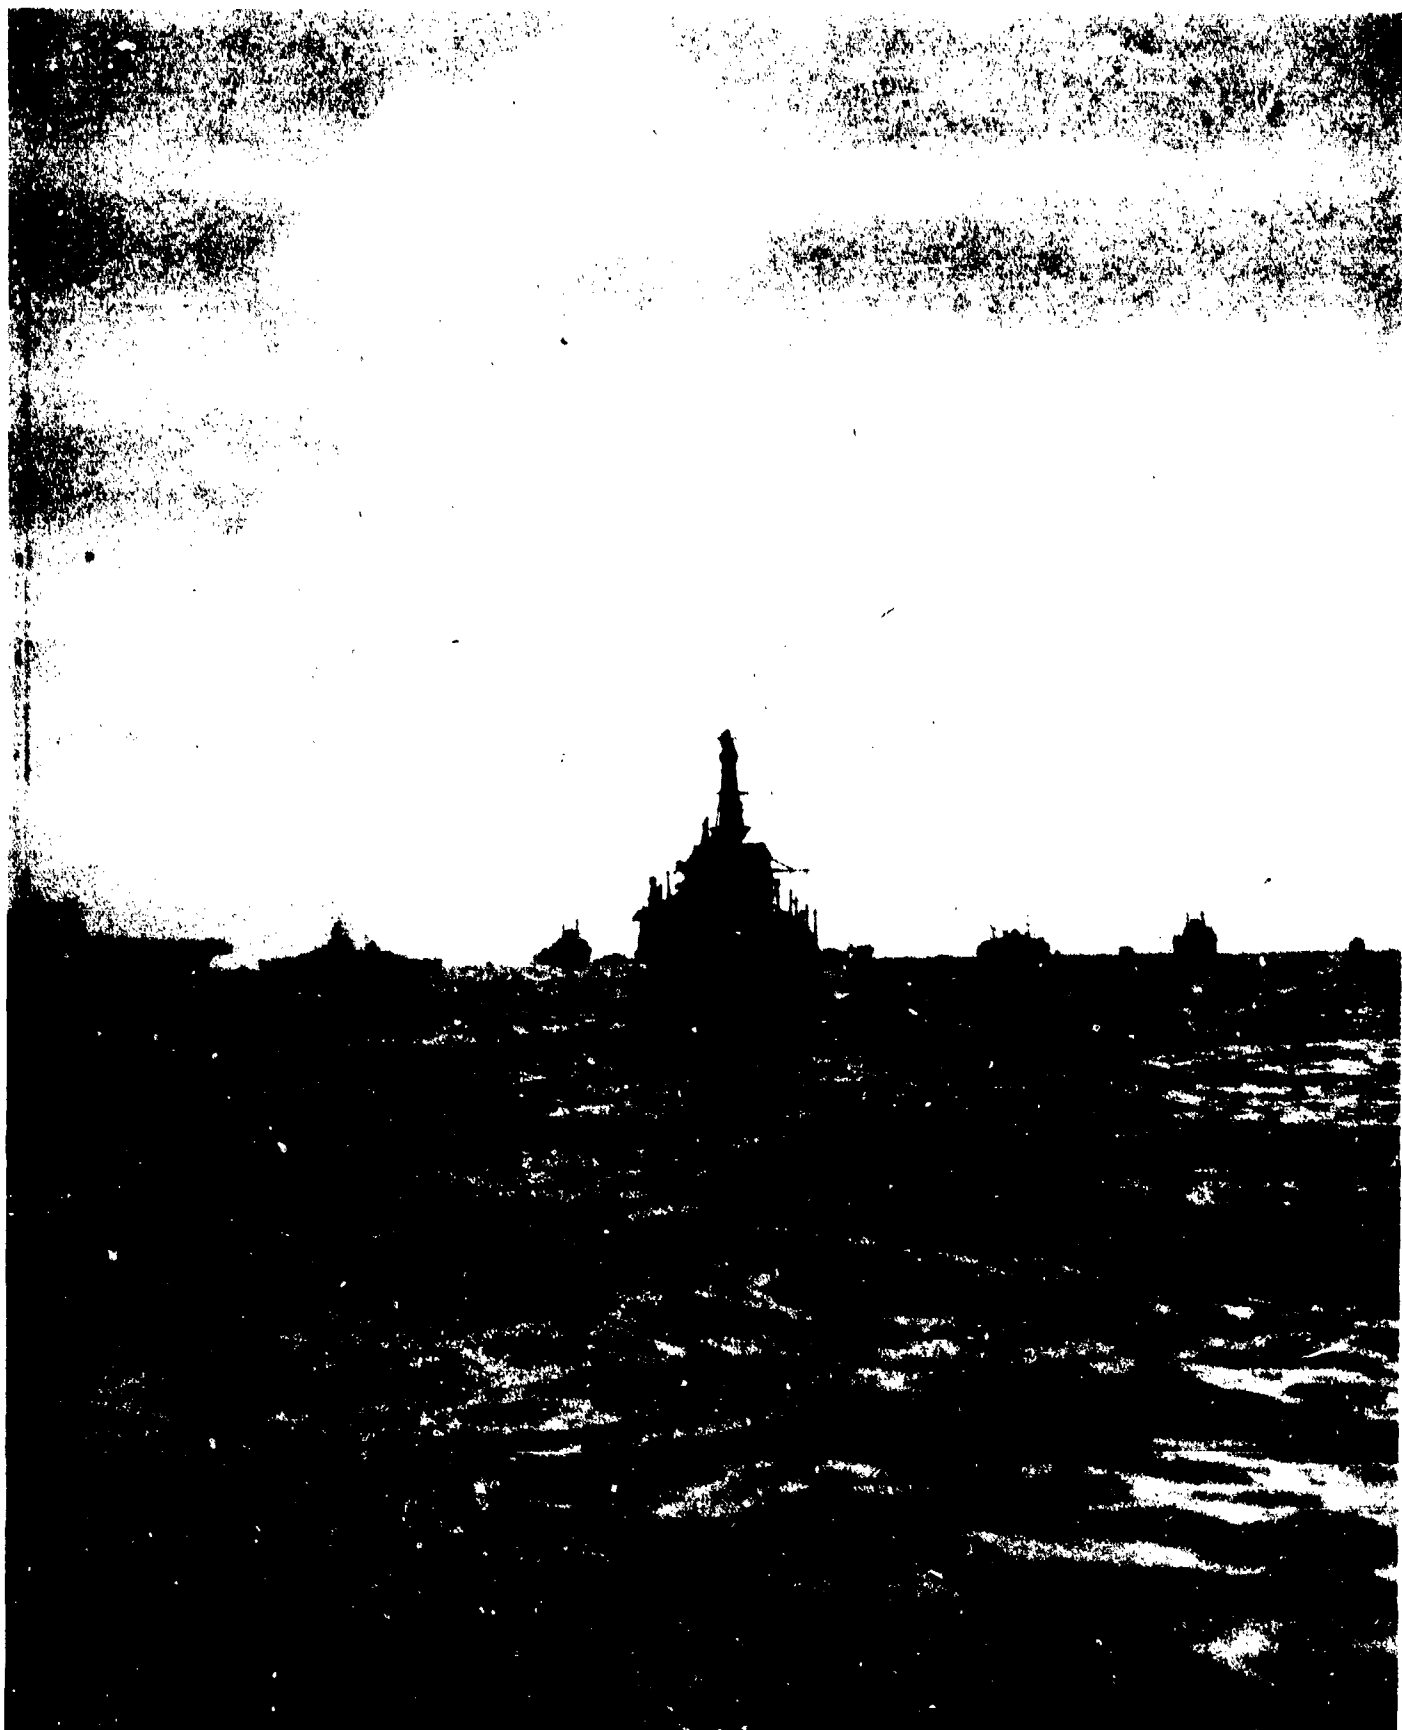
AACR-227-92-84. General view from ahead.

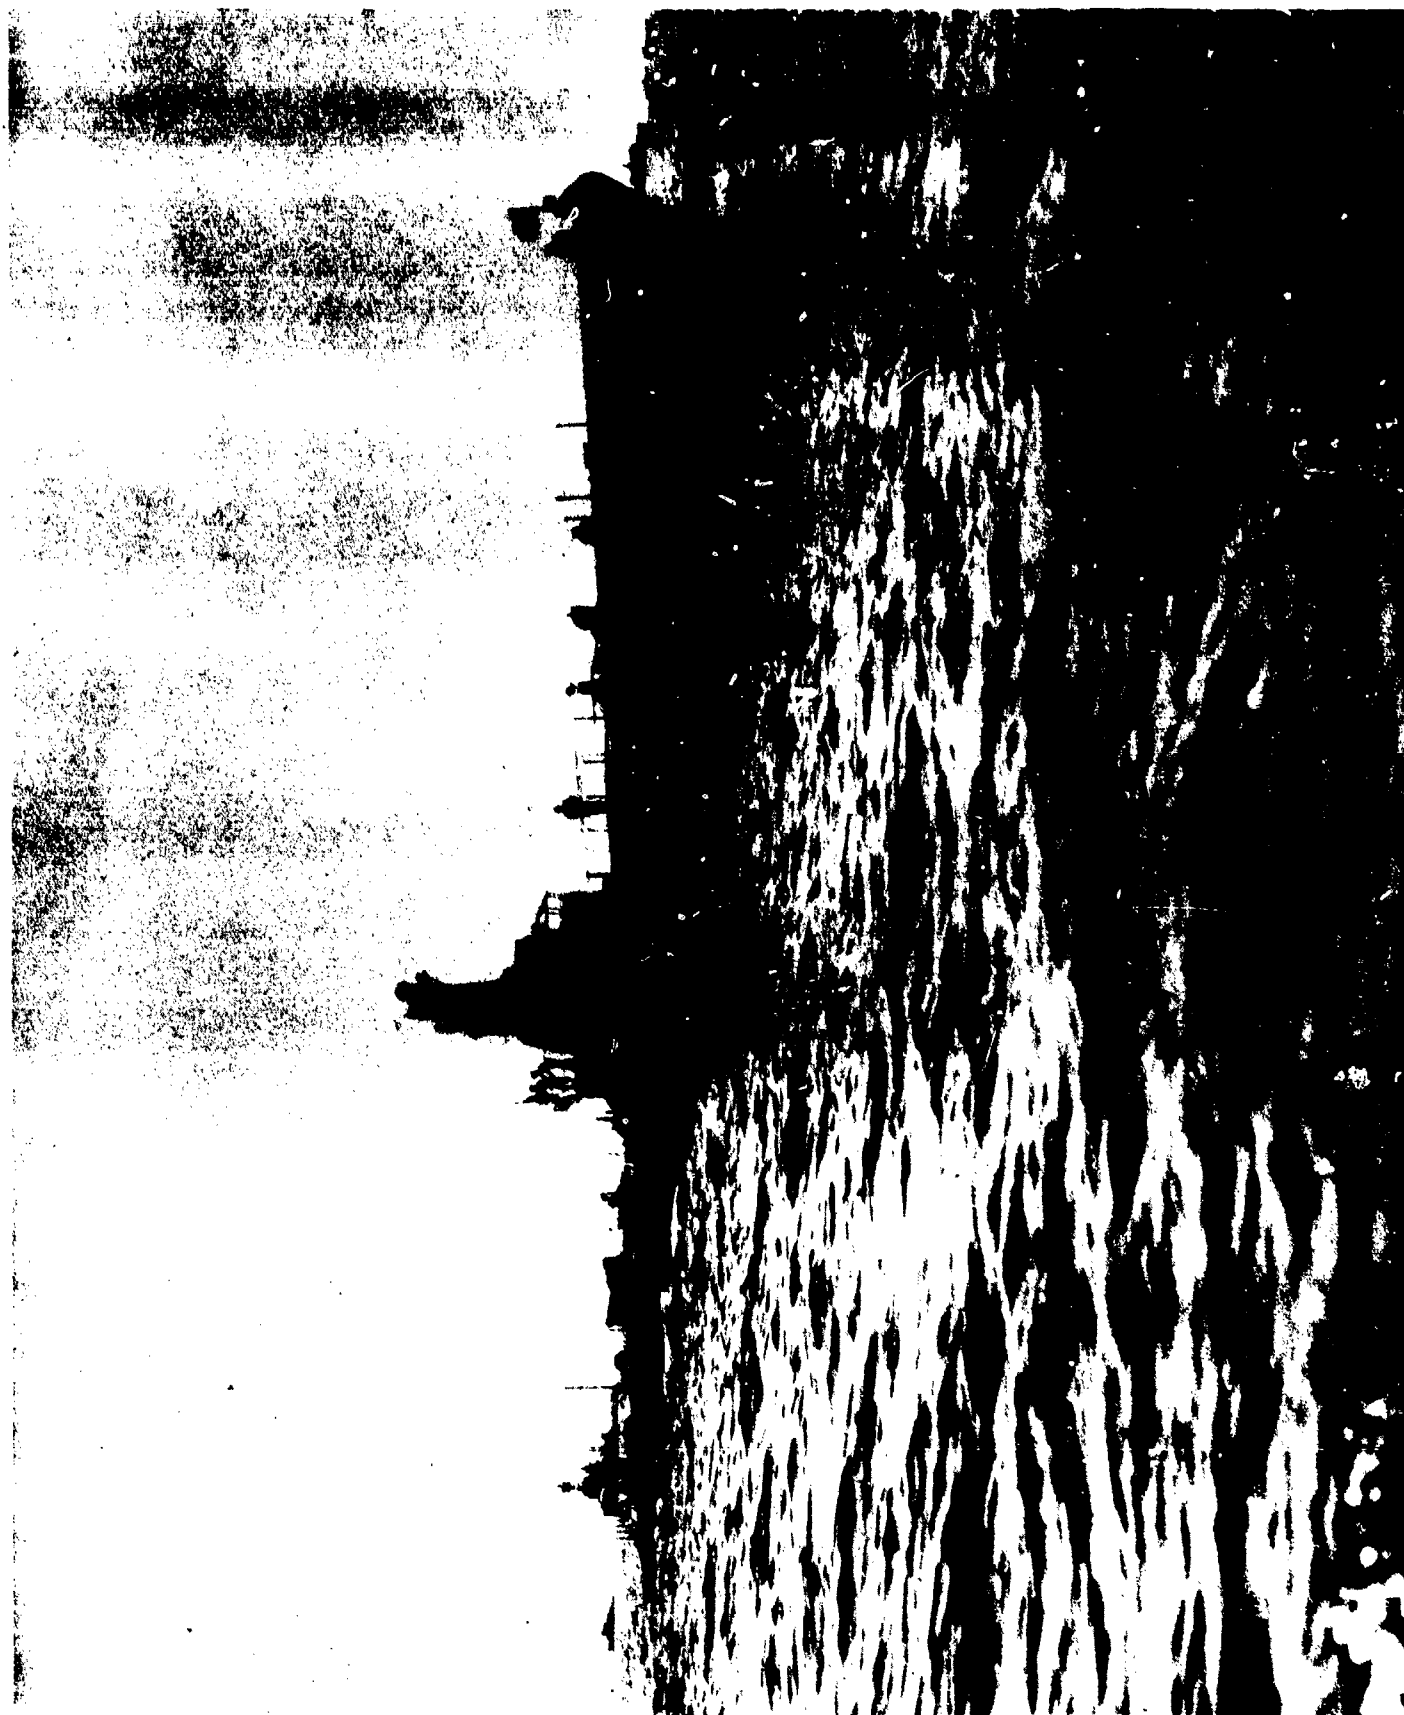
AACR-227-92-85. General view from starboard bow.

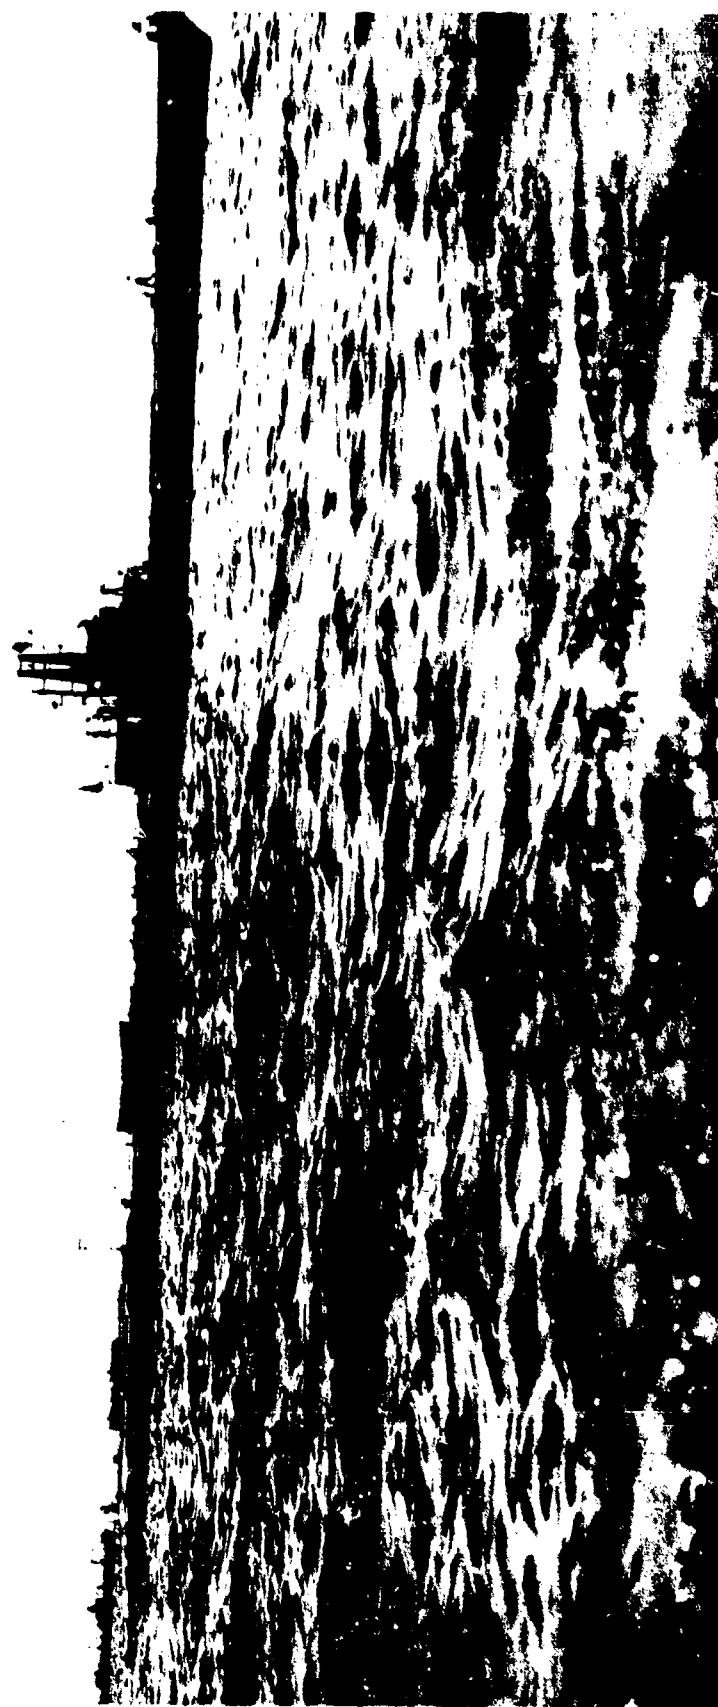
AACR-227-92-86. General view from starboard beam.

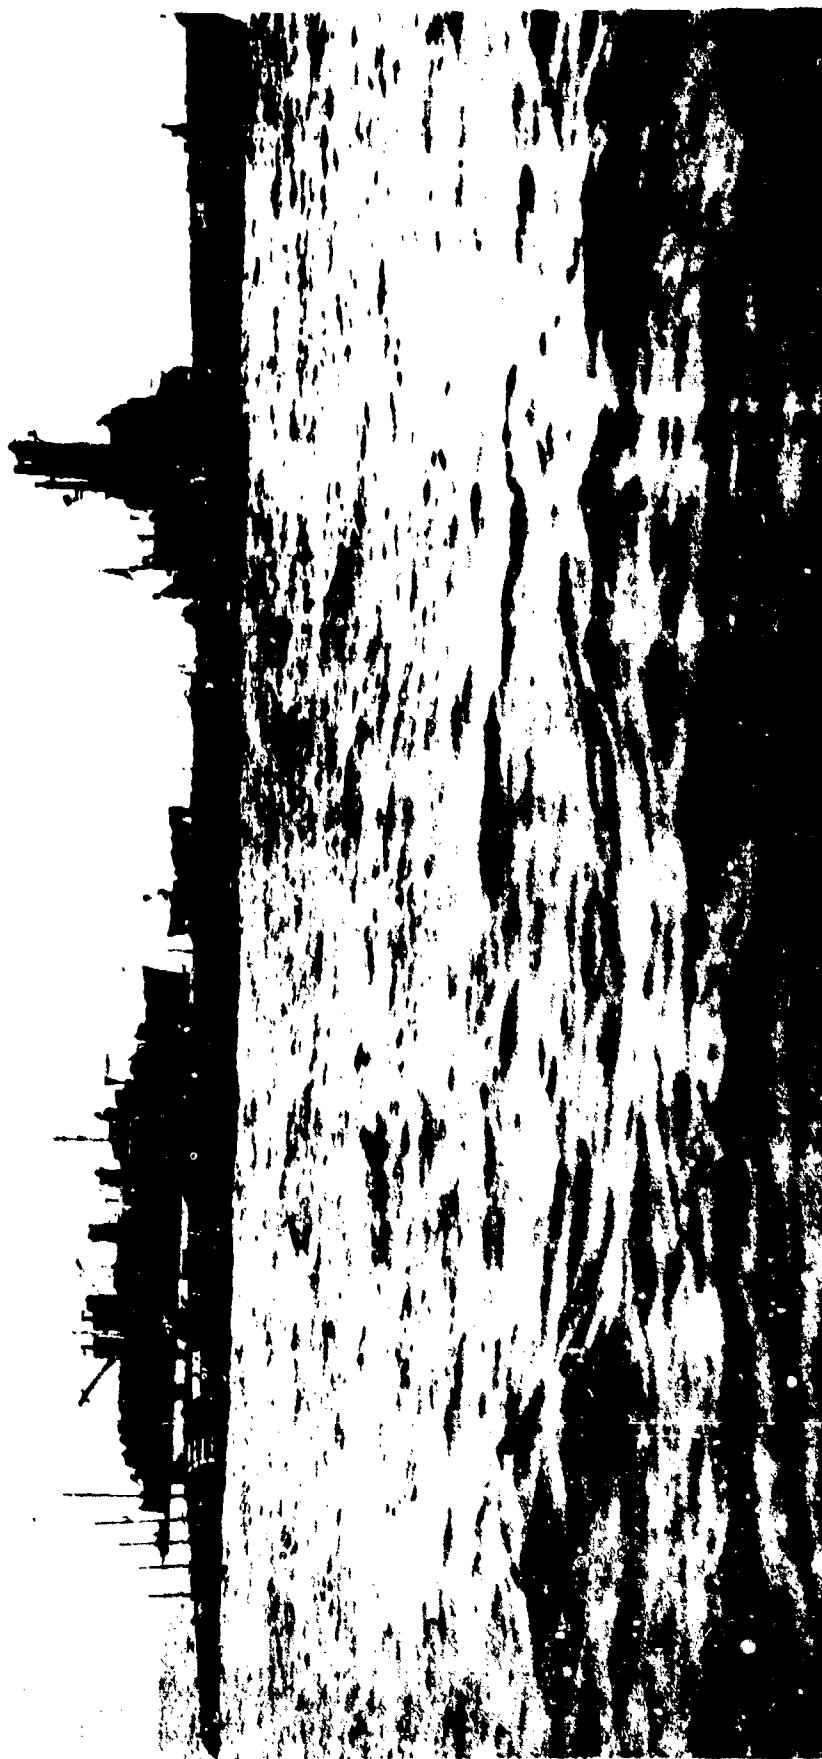
AACR-227-92-87. General view from starboard quarter.

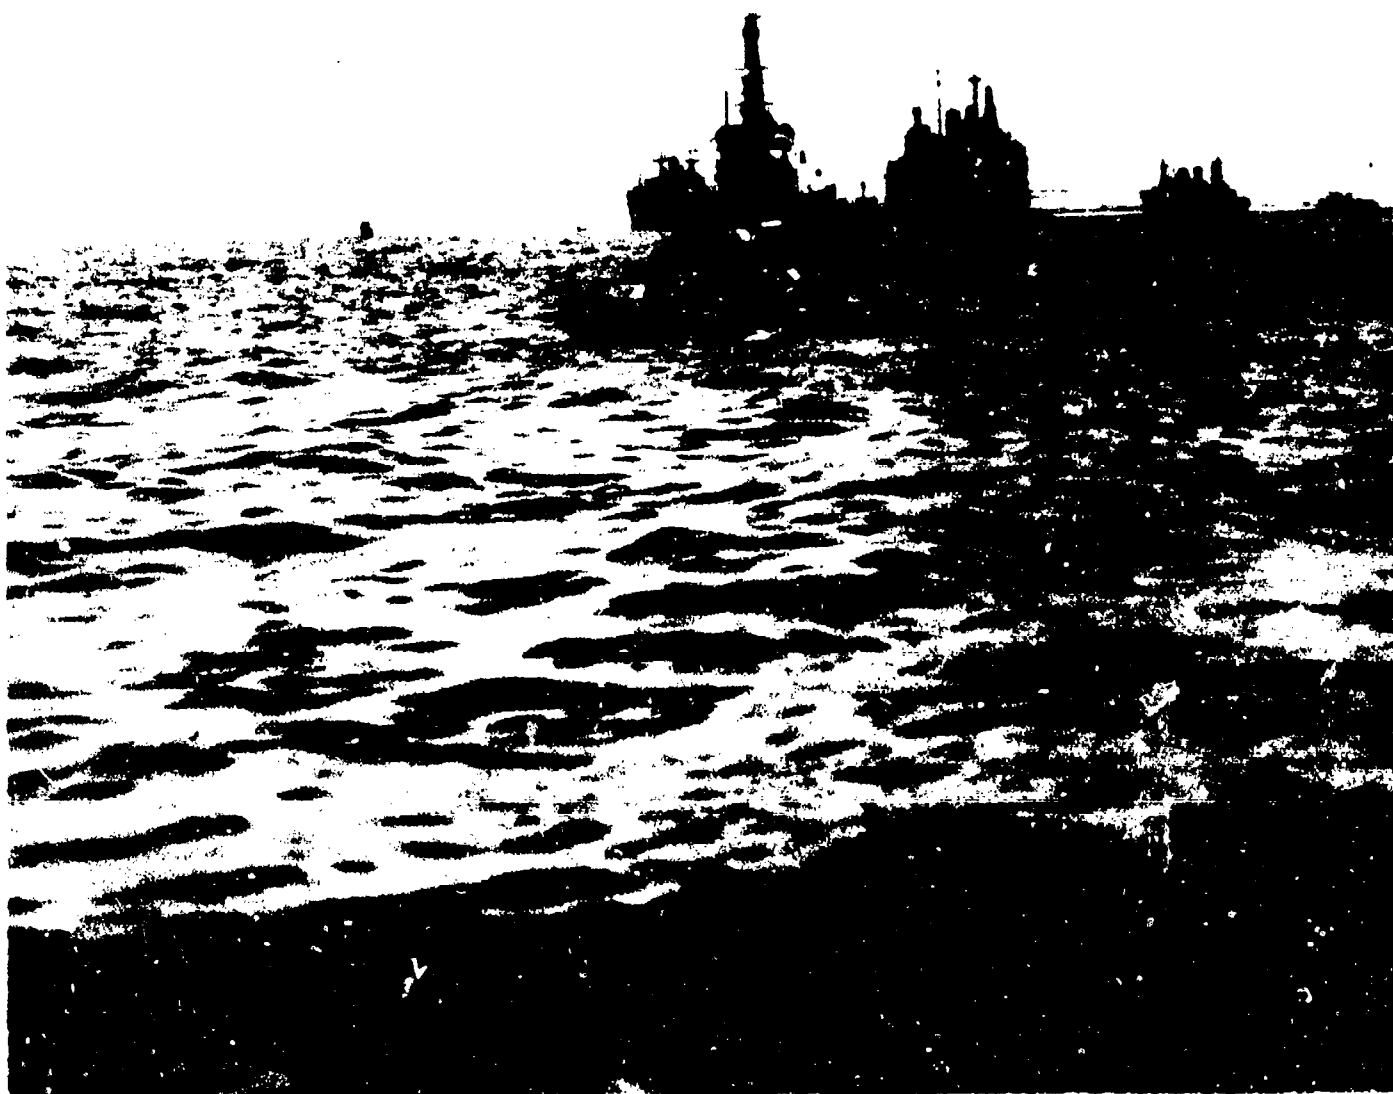
AACR-227-92-88. General view from astern.

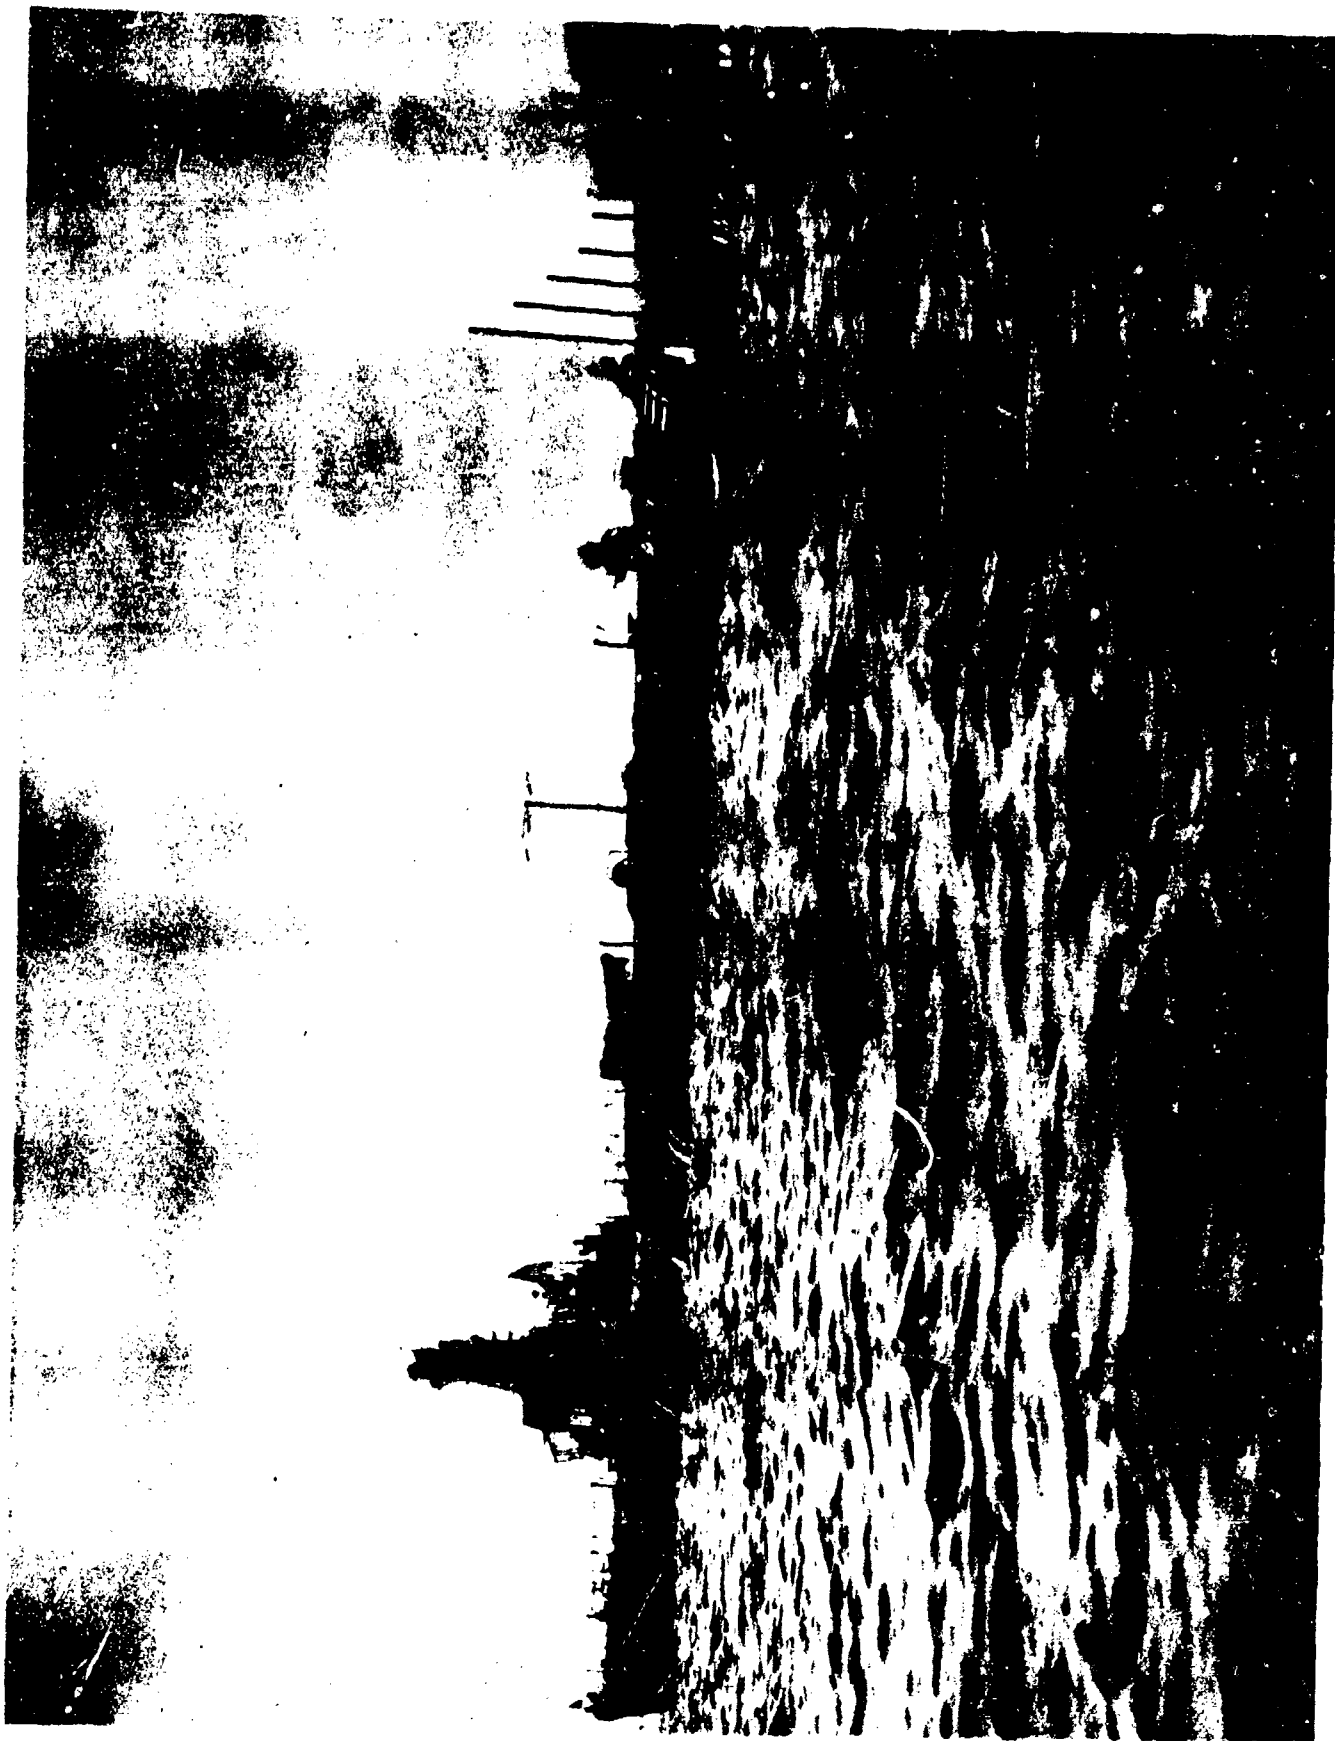
AACR-227-92-82. General view from port quarter.

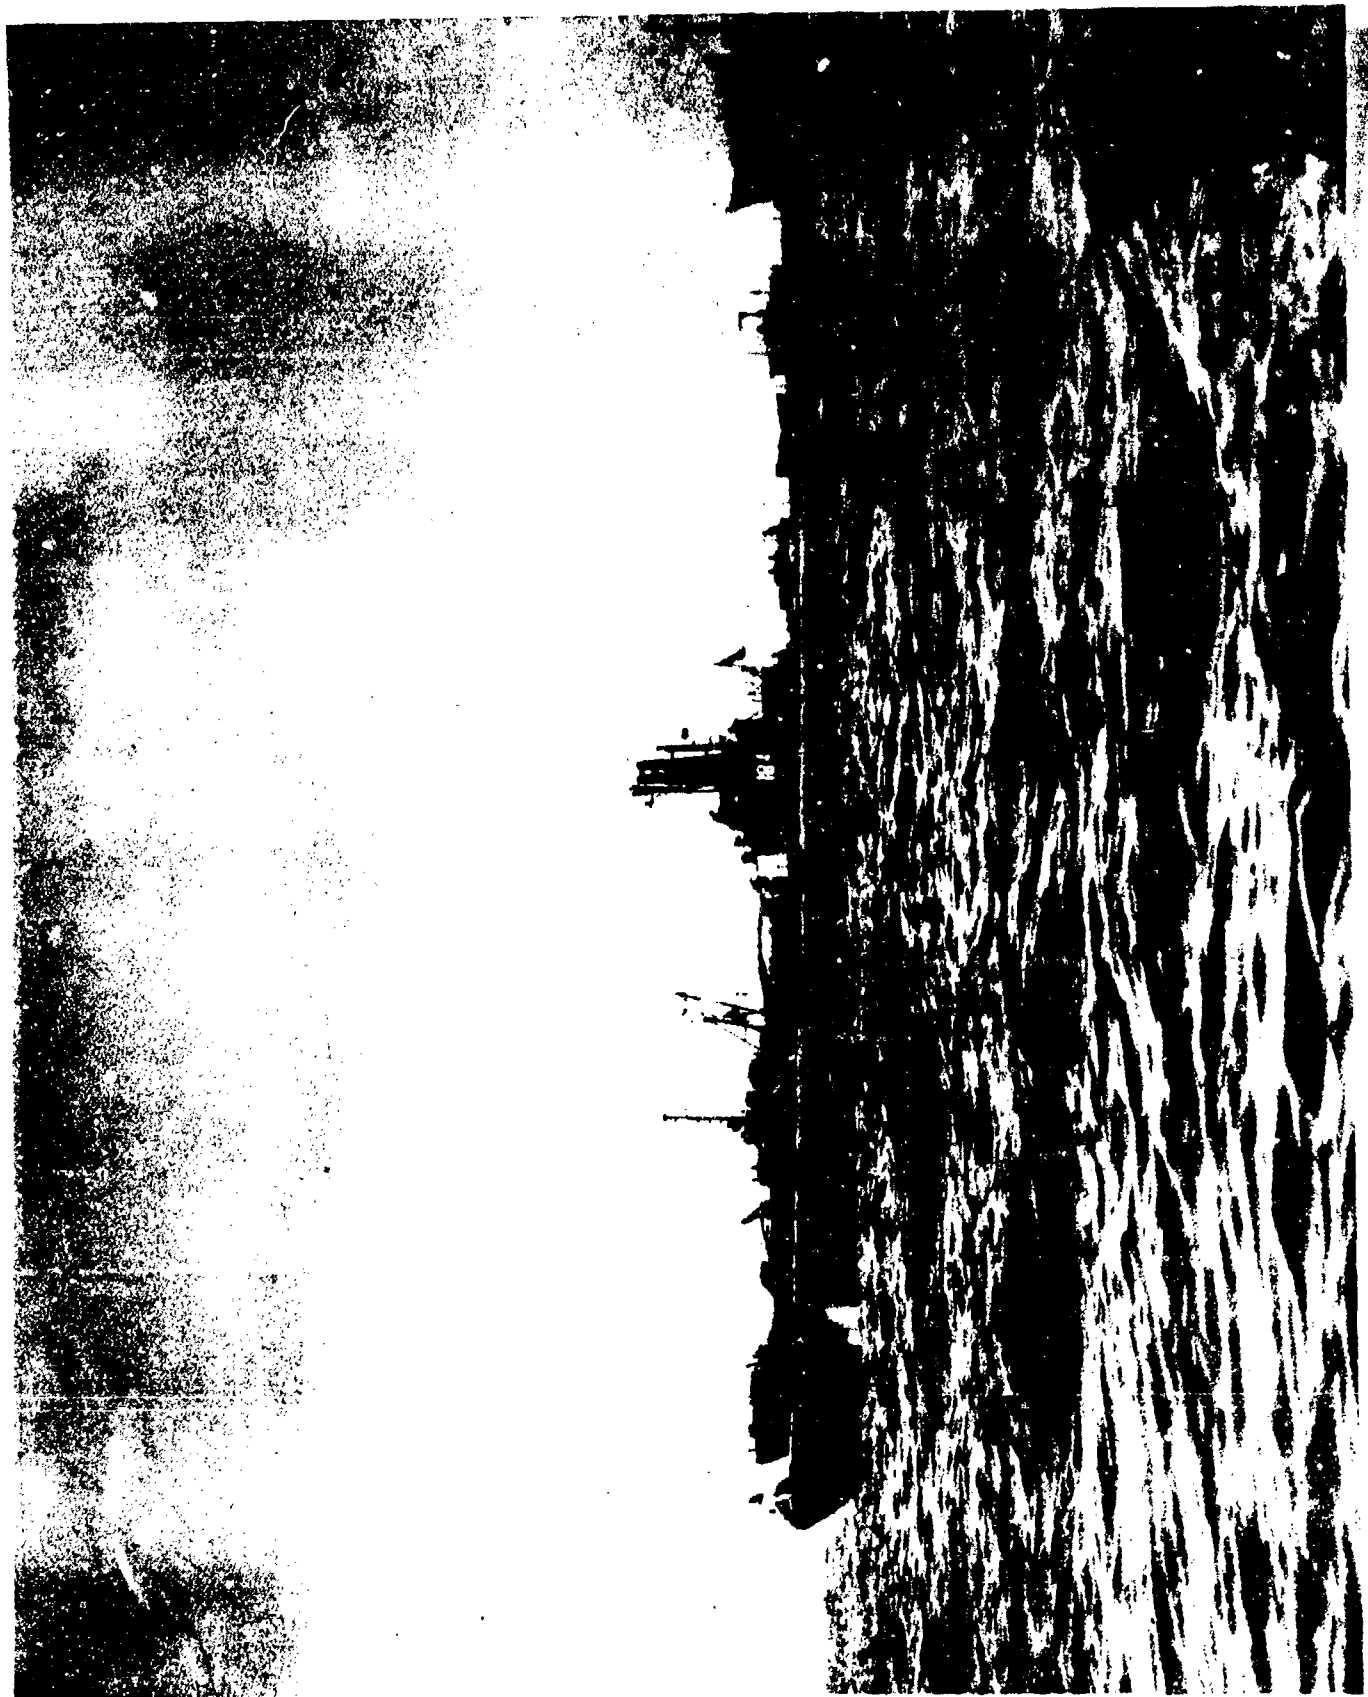
AACR-227-92-83. General view from port bow.
